# 21154 PCI-to-PCI Bridge

## Specification Update

*July 2004*

Order Number: [278295-017](#)

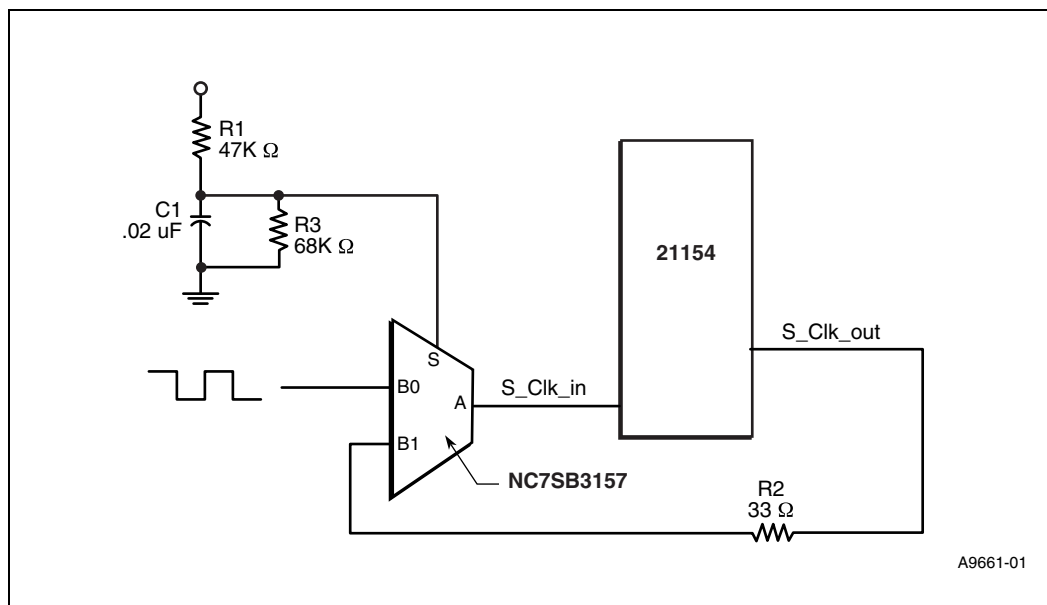
**Figure 1. S\_Clock Multiplexer Workaround Circuit for Errata 6.**

## 6. Secondary Clocks Outputs s\_clk\_o<9:0> May Not Start-up Properly Under Some Conditions

**Problem:** This problem has been found on the 21154AC and 21154BC. Under repeated and frequent power cycling, the secondary clock circuits may not power up in the proper state, resulting in the device not coming out of reset after power up.

1. [Figure 1](#) illustrates the first recommendation - a circuit where an on-board pulse source is gated via the B0 input of the multiplexer to the S\_Clock\_in pin of the 21150.

The values used for the R/C network should be selected to allow a minimum of 2 pulses to be delivered to the 21150 after Vdd has reached 3.0V at a frequency not to exceed the appropriate PCI component. i.e. 30 ns for a 33Mhz bridge. These values should be chosen based on the rise time of the power supply and the frequency of the on board pulse source. The values given for R1, R3, and C1 are for example purposes only.

**Note:** The NC7SB3157 2:1 Multiplexer / Demultiplexer Bus Switch used in this example has a maximum propagation delay of 800ps that should be taken into consideration when matching trace lengths of the clock lines to avoid introducing excessive skew in the clocks. All S\_Clock etch lengths must be matched to within 2ns @ 33Mhz or 1ns @ 66Mhz. The addition of this circuit requires that the etch length for the S\_clock\_in signal be reduced to compensate for the 800ps delay.

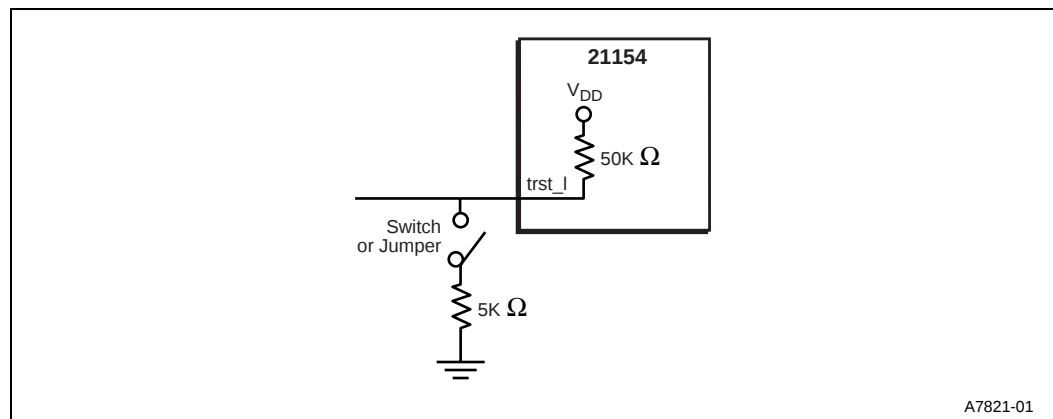
Figure 6. Removal of Pull-Down Resistor for JTAG Testing

A 5 K  $\Omega$  pull-down resistor is required on trst\_l for normal PCI-to-PCI bridge operation. However, some JTAG test results may be inconclusive if the 5 K  $\Omega$  resistor remains in the circuit. To obtain accurate JTAG results, Intel recommends one of the following solutions:

- Verify that the JTAG test equipment, after driving trst\_l low to reset the TAP controller, constantly drives trst\_l high during JTAG tests. If this signal is not constantly driven high, the 5 K  $\Omega$  resistor will pull the signal to a low state.
- Remove the 5 K  $\Omega$  resistor during JTAG tests. This resistor must be installed during normal PCI-to-PCI bridge operation.
- Design external circuits with a switch or jumper to isolate the 5 K  $\Omega$  resistor during JTAG tests (see Figure 6). This switch must enable the resistor during normal PCI-to-PCI bridge operation.

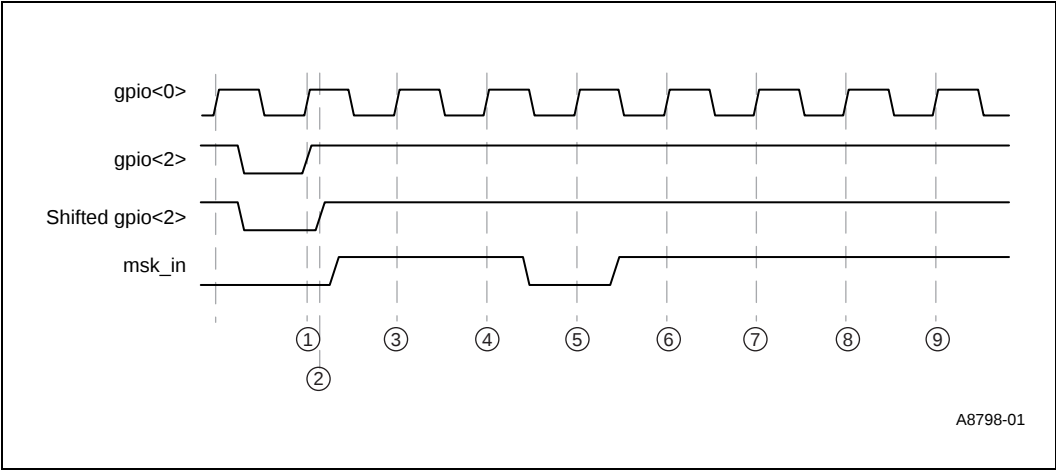
Figure 21. Clock Mask and Load Shift Timing

1. The **gpio<2>** original coming from the 21154 does not provide 3ns setup time needed to provide the parallel load enable **PE#** of the 74F166.
2. The shifted **gpio<2>** is delayed by ~9ns to provide ample setup time to enable the parallel of the shift register connected to pin 15 of the 74F166.
3. Bit 15 input **D6** of the shift register is pulled high, to Vcc.
4. Bit 14 input **D7** is pulled high, to Vcc. These signals are not used internally in the 21154.
5. Bit 13 **s\_clk\_o<9>** is a feedback to the 21154 **s\_clk\_o** input. To enable **s\_clk\_o<9>** in all cases the **D5** input of the shift register is grounded, to Vss.
6. Bit 12 **s\_clk\_o<8>** is disabled.
7. Bit 11 **s\_clk\_o<7>** is disabled.
8. Bit 10 **s\_clk\_o<6>** is disabled.
9. Bit 9 **s\_clk\_o<5>** is disabled.
