# 21154 PCI-to-PCI Bridge

## Specification Update

*July 2004*

Order Number: [278295-017](#)

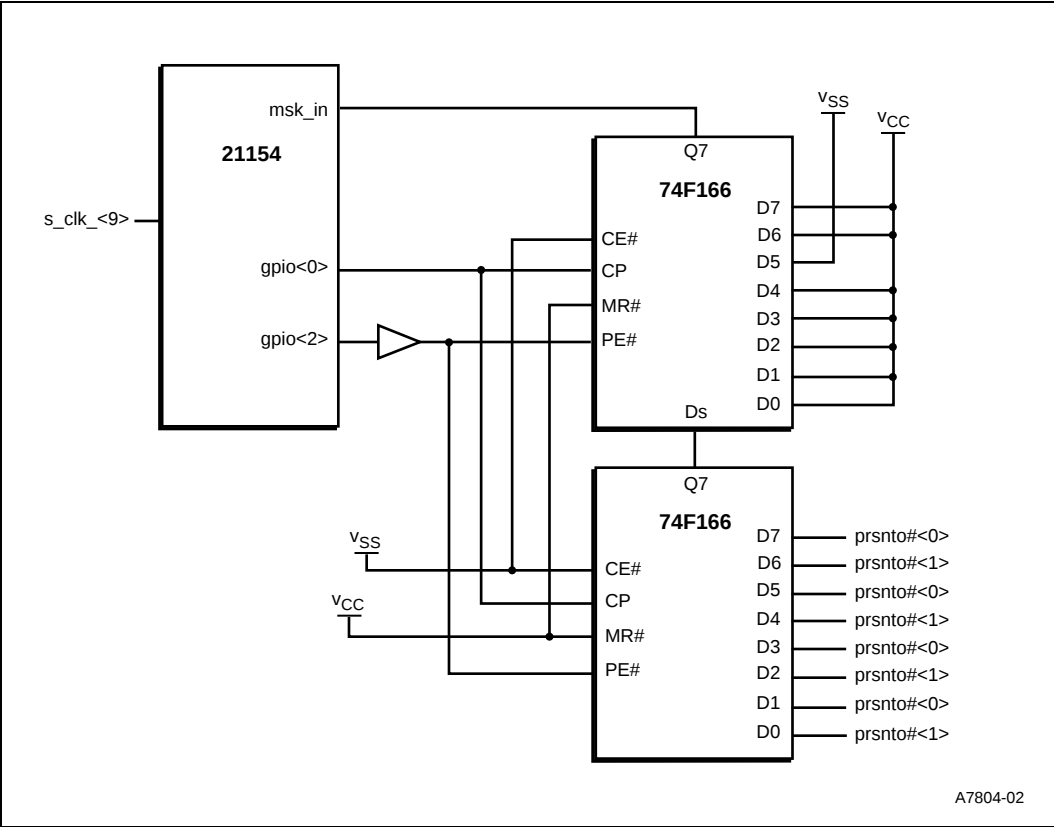
Figure 19 Example of GPIO Clock Mask Implementation on the System Board

12. Section 10.2, Secondary Clock Control, Figure 19

This figure now appears as follows:

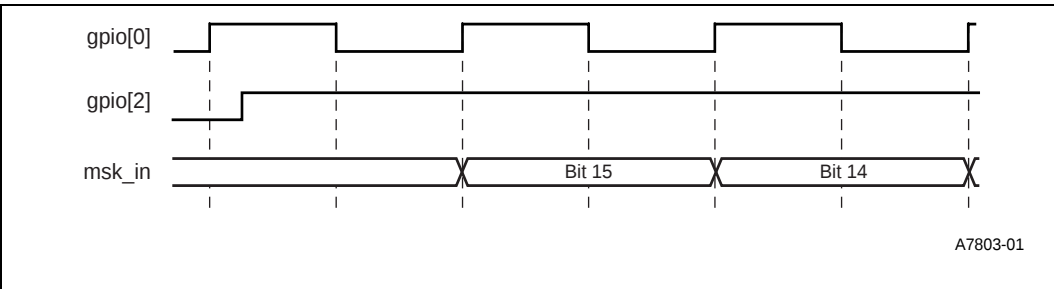
Figure 20. Clock Mask and Load Shift Timing

13. Section 10.2, Secondary Clock Control, Figure 20

This figure now appears as follows:

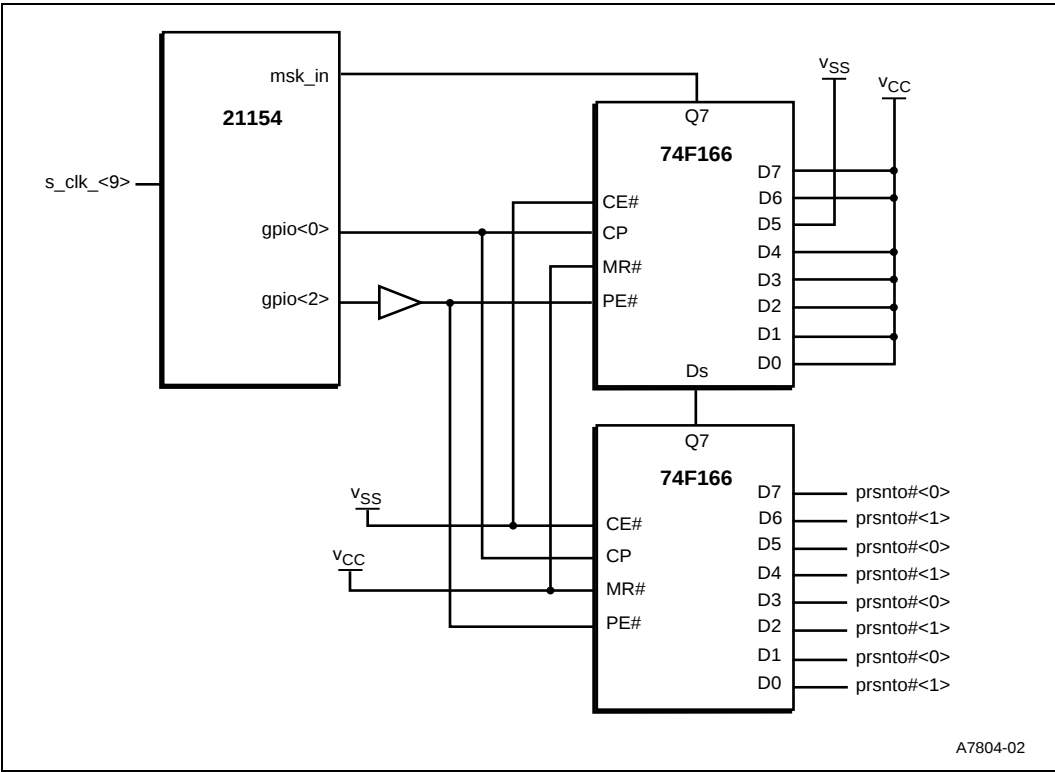
Figure 3 Example of GPIO Clock Mask Implementation on the System Board

**18. Section 4.4.1, Serial Clock Mask Shift, Figure 3**

Figure 3 has been updated as follows:

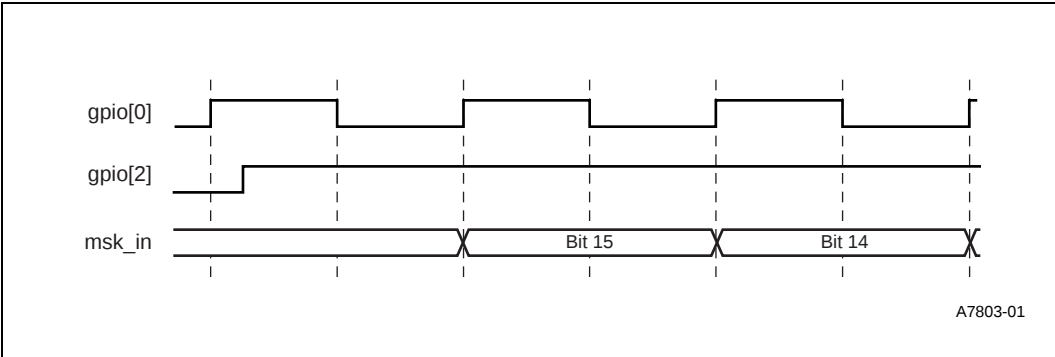
Figure 4. Clock Mask Load and Shift Timing

19. Section 4.4.1, Serial Clock Mask Shift, Figure 4

Figure 4 now appears as follows:
