# LED Soldering Iron Kit – 40 Watt, 120 V PART NUMBER: SP40NKUS

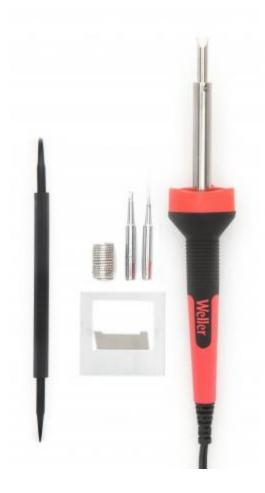
- Weller Consumer Soldering Iron Kits w/3 LED's
- Three LED lights for limited application shadowing
- Round Co-molded soft grip handle design for easy tip positioning
- Triangular handle area for maximum tip control
- Stainless steel heater construction
- UL listed cUL version available
- Excellent quality consumer iron
- IMPORTANT: Use only original Weller tips
