# Intel® 810 Chipset Family: 82810/82810-DC100 Graphics and Memory Controller Hub (GMCH)

Specification Update

Document Number: 290659-003

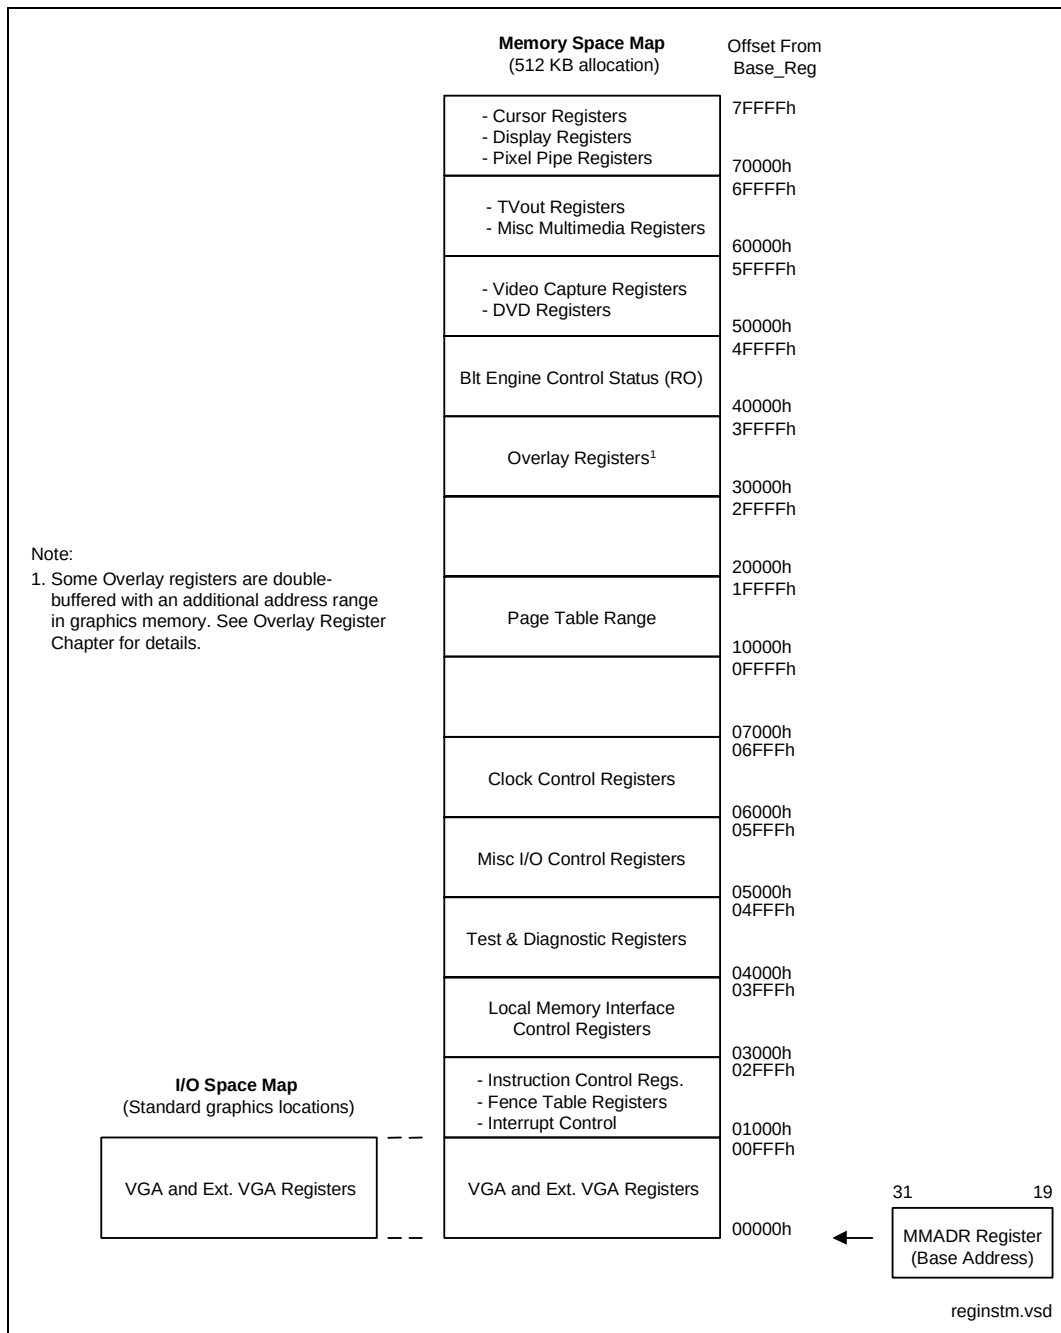
## 1. Changed: GMCH Graphics Controller Register Memory

Figure 6 (*GMCH Graphics Register Memory Address Space*), Section 4.1.1.2, Extended Memory Area, is replaced with the figure below.
